Manhole Inspection Summary

Manhole # S39MM_001MH

Insp Date: **3/1/07 11:30 AM**

Location Address: **1904 HOPE ST**

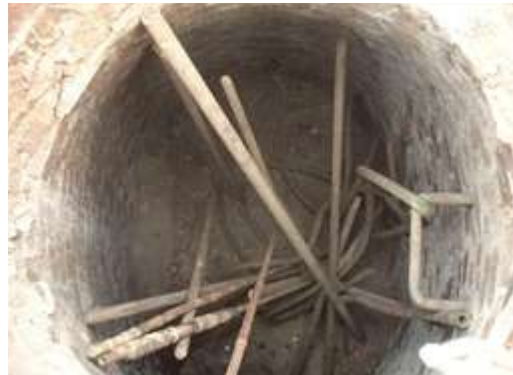
Top View

Adjustment deterioration and infiltration.
Channel debris.

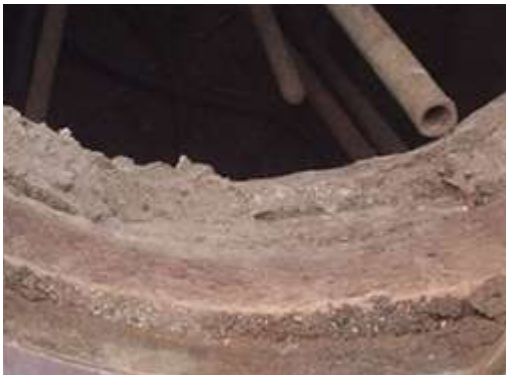
Defect

Offset: **1** (in.)

☒ **Leaks**

Frame leaks. Frame offset. Adjustment
infiltration.

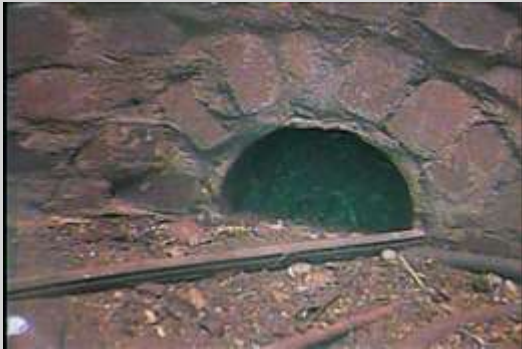
8 in. Circular Gravity Sewer
Pipe Out @ 12 O'Clock

Deposits: ☐ None ☐ Mud ☐ Sludge ☒ **Debris** ☐ Grease

Silt Depth: **3** (in.) Deposits Extent: **Medium**
